Fire SaFety Fol low up inSpection

<b>Factory Name</b>	<b>Mondol Intimates Ltd.</b>		<b>Accord ID</b>	<b>11705</b>
<b>Address</b>	<b>Shirir Chala, Bagherbazar</b>			
<b>Inspection Date</b>	<b>09/07/2014</b>		<b>Report Received Date</b>	
<b>Date of 1st Follow-up</b>	17/August/15	<b>Date of 2nd Follow-up</b>	18/February/16	
<b>Date of 3rd Follow-up</b>	19/April/16	<b>Date of 4th Follow-up</b>	21/August/16	
<b>Date of 5th Follow-up</b>	30/October/16	<b>Date of 6th Follow-up</b>	02/January/17	
<b>Date of 7th Follow-up</b>	27/March/17	<b>Date of 8th Follow-up</b>	05/July/17	
<b>Date of 9th Follow-up</b>		<b>Date of 10th Follow-up</b>		
<b>Inspected by</b>	Md. Abdul Karim

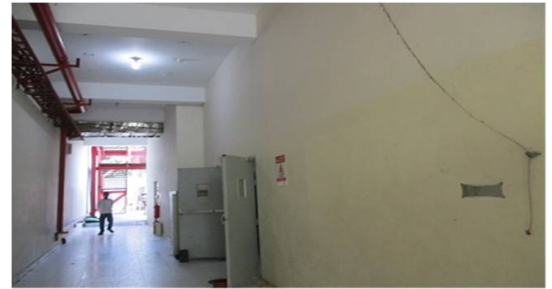
1	The generator and transformer room is not separated by fire-rated construction.	Separate the generator and transformer room by a minimum 2-hr fire-rated construction. Seal and/or protected all openings to maintain the required fire separations	Within 3 months	<p>On 21.08.2016: It was found same as before during 4th follow-up Inspection.</p> <p>On 30/10/2016: Work in progress.</p> <p>On 02/01/2017: Partially done. Transformer room has an exhaust fan opening where factory has an exit stair.</p> <p>On 27/03/2017: Found same as it was before. Door coordinators, smoke seals were missing.</p> <p>On 05/07/2017: It has been found same as the previous follow up.</p>	30/05/2016		In Progress

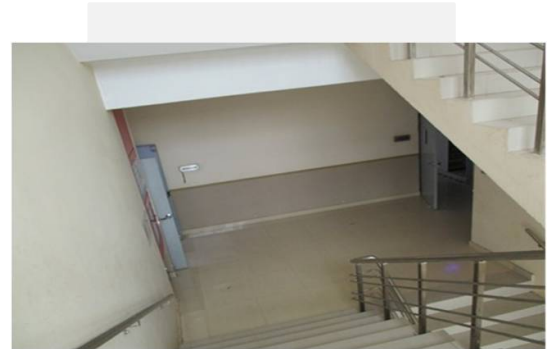
2	The exit stairs are not separated from work areas on each floor by fire-rated construction.	Provide minimum 1.5-hr fire rated doors and seal all unprotected openings to separate the exit stairs from work areas and other building spaces on all floor levels. Ensure that the fire doors are self-closing and positive latching and that they are provided with fire exit (panic) hardware where serving production floors. If fire doors are required to be held open for functional reasons, provide automaticclosing devices tied to the fire alarm system.	Within 3 months	<p>On 21.08.2016: It was found same as before during 4th follow-up Inspection.</p> <p>On 30/10/2016: It was found same as it was last (4th) follow-up Inspection.</p> <p>On 02/01/2017: Partially done. Interfacing with FACP is pending in the installed doors. Non-certified doors have been found in the steel stair. Those need to be replaced.</p> <p>On 27/03/2017: North-east (external) stair is not separated yet. Fire door installation work is still pending. Besides installed fire doors were not closing properly. Smoke seal, door coordinators were missing. Factory was keeping the doors open through some external source. Closers were not functional.</p> <p>On 05/07/2017: It has been found same as the previous follow up and fire door installation is going on at north-east exit stair.</p>	30/05/2016	We install all fire rated door in exit stairs.Complete	In Progress

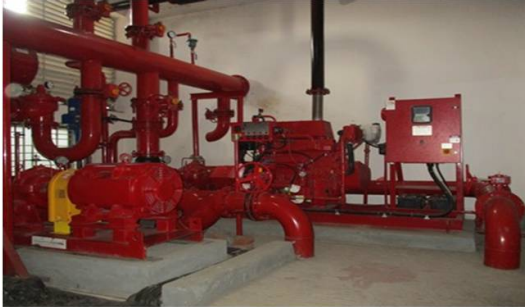
Item No	Accord Observation	Accord Recommendation	Timeline given by Accord	Comments after Physical Inspection	Supposed to complete(DD/MM/YYYY)	Final Action Plan (Factory)	Status on the date of Inspection	Pictorial Evidence
6	The high-rise building has an occupied floor greater than 23m (75 ft) and is not provided with automatic sprinkler protection. The large occupant loads, heavy fuel loading, and anticipated extended egress times warrant sprinkler protection.	Provide automatic sprinkler protection throughout the building in accordance with NFPA 13.	Design within 6 months, install within 12 months	<p>On 21.08.2016: In progress. Design has been reviewed from Accord and installation is going on.</p> <p>On 30/10/2016: Work in progress. Design has been reviewed from Accord and installation is going on.</p> <p>On 02/01/2017: Installation work is going on. Pump &amp; other accessories are in housed. Warehouse section has not been covered by sprinkler system.</p> <p>On 27/03/2017: ACCORD reviewed design was available during the time of inspection. Installation work is in progress. Ground floor pending.</p> <p>On 05/07/2017: ACCORD reviewed design was available on site during follow up inspection and installation is going on.</p>	18/05/2016	Maximum work is completed. Now we are wait for contractor testing & inspection.	In Progress

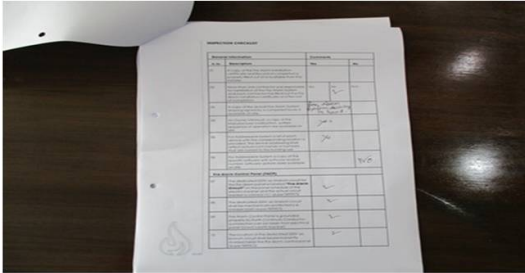
7	Inspection, testing, and maintenance of the fire alarm system is not in accordance with NFPA 72.	Inspect, test and maintain the fire alarm system, and keep written records on-site, in accordance with NFPA 72.	Within 3 months	<p>On 21.08.2016: It was found same as before during 4th follow-up Inspection.</p> <p>On 30/10/2016: Corrected. Factory is maintaining the checklist as per the standard.</p> <p>On 02/01/2017: Corrected. Factory is maintaining the checklist as per the standard.</p> <p>On 27/03/2017: Corrected. Factory is maintaining the checklist as per the standard.</p> <p>On 05/07/2017: Corrected as per previous follow up.</p>	30/05/2016	Completed	Corrected

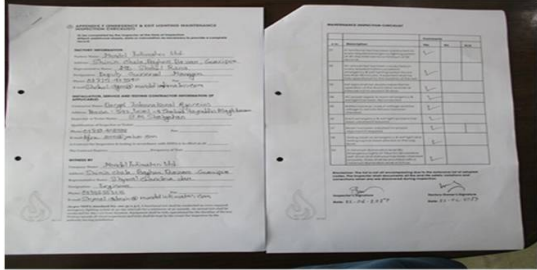
Item No	Accord Observation	Accord Recommendation	Timeline given by Accord	Comments after Physical Inspection	Supposed to complete(DD/MM/YYYY)	Final Action Plan (Factory)	Status on the date of Inspection	Pictorial Evidence
9	Inspection, testing, and maintenance for the emergency lighting system was not in accordance with The ACCORD standard.	Inspect, test and maintain the emergency lighting system in accordance with The ACCORD standard. Keep written records on-site.	Within 3 months	<p>On 21.08.2016: It was found same as before during 4th follow-up Inspection.</p> <p>On 30/10/2016: Corrected. Factory is maintaining the checklist as per the standard.</p> <p>On 02/01/2017: Corrected. Factory is maintaining the checklist as per the standard.</p> <p>On 27/03/2017: Corrected. Factory is maintaining the checklist as per the standard.</p> <p>On 05/07/2017: Corrected as per previous follow up.</p>	30/05/2016	Completed	Corrected

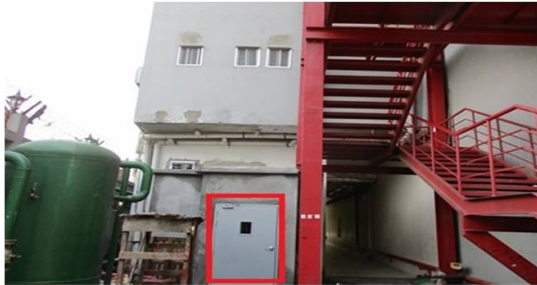
10	New Finding (1st Follow-up): Diesel storage tank located in the northeast egress path of ground floor is not separated by fire rated construction.	Separate the diesel storage tank by a minimum 2-hr fire-rated construction. Seal and/or protected all openings to maintain the required fire separations	Within 3 months	<p>On 21.08.2016: It was found same as before during 4th follow-up Inspection.</p> <p>On 30/10/2016: No action has been taken yet.</p> <p>On 02/01/2017: No action has been taken yet.</p> <p>On 27/03/2017: No action has been taken yet.</p> <p>On 05/07/2017: Corrected. Factory has completed installation of fire door and related civil work. If fire doors are required to be held open for functional reasons then fire doors are required to interface with the fire alarm system.</p>	30/05/2016		Corrected

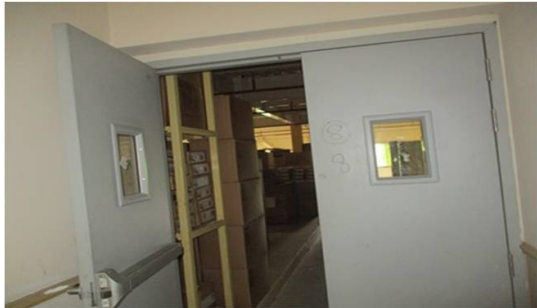
11	New Finding (1st Follow-up): Rooms used for combustible storage are not separated by fire-rated construction. Location: Ground floor's accessories and fabric store, wastage store on northeast egress path.	Provide dedicated storage rooms separated by minimum 1-hr fire-rated construction. Seal all penetrations and openings to maintain required fire separation.	Within 3 months	<p>On 21.08.2016: It was found same as before during 4th follow-up Inspection.</p> <p>On 30/10/2016: Partially corrected. Fire door has been installed without interfacing with FACP and openings &amp; penetrations has not been sealed properly.</p> <p>On 02/01/2017: Partially done. Doors need to be interfaced with FACP. Goods were not kept in a proper way. Aisles were not maintained.</p> <p>On 27/03/2017: Partially corrected. Door coordinators, smoke seals were missing. Besides factory was keeping the doors open through some external sources.</p> <p>On 05/07/2017: It has been found same as previous follow up.</p>	30/05/2016	we are already seal the all unsealed penetration. Also provide ddicated storage for all accessories, fabri cs etc.complete.	In Progress

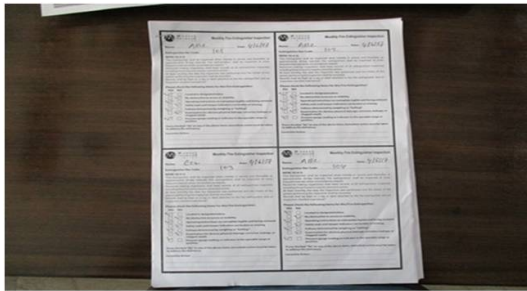
Item No	Accord Observation	Accord Recommendation	Timeline given by Accord	Comments after Physical Inspection	Supposed to complete(DD/MM/YYYY)	Final Action Plan (Factory)	Status on the date of Inspection	Pictorial Evidence
20	New Finding: (3rd Follow-up): Inspection, testing, and maintenance of the portable fire extinguishers is not in accordance with NFPA 25 or as per Accord standard.	Inspect, test and maintain the portable fire extinguishers, and keep written records on-site, in accordance with NFPA 25 or as per Accord standard.	Within 1 month	On 21.08.2016: Not corrected. Factory shall maintain it as per code. On 30/10/2016: Corrected. Factory is maintaining the checklist as per the standard. On 02/01/2017: Corrected. Factory is maintaining the checklist as per the standard. On 27/03/2017: Corrected. Factory is maintaining the checklist as per the standard.  On 05/07/2017: Corrected as per previous follow up.	19/05/2016	Completed	Corrected

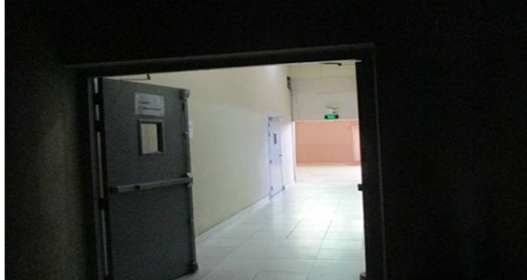
23	New Finding: (3rd Follow-up): Shutter type doors have provided along exit discharge. Location: Ground floor ware-house exit.	Replace all collapsible/sliding/shutter type doors & gates by the side-hinged swinging type doors.  If locks are required for security reasons, utilize special door locking features complying with NFPA 101.	Immediately.	On 21.08.2016: It was found same as before during 4th follow-up Inspection. On 30/10/2016: Corrected. Removed and replaced by side-hinged swinging type doors. On 02/01/2017: Corrected. On 27/03/2017: Corrected. Removed.  On 05/07/2017: Corrected as per previous follow up.	30/04/2016	Completed	Corrected
